Water Leaks are Money down the Drain

by Steve Johnson, ToolingDocs LLC

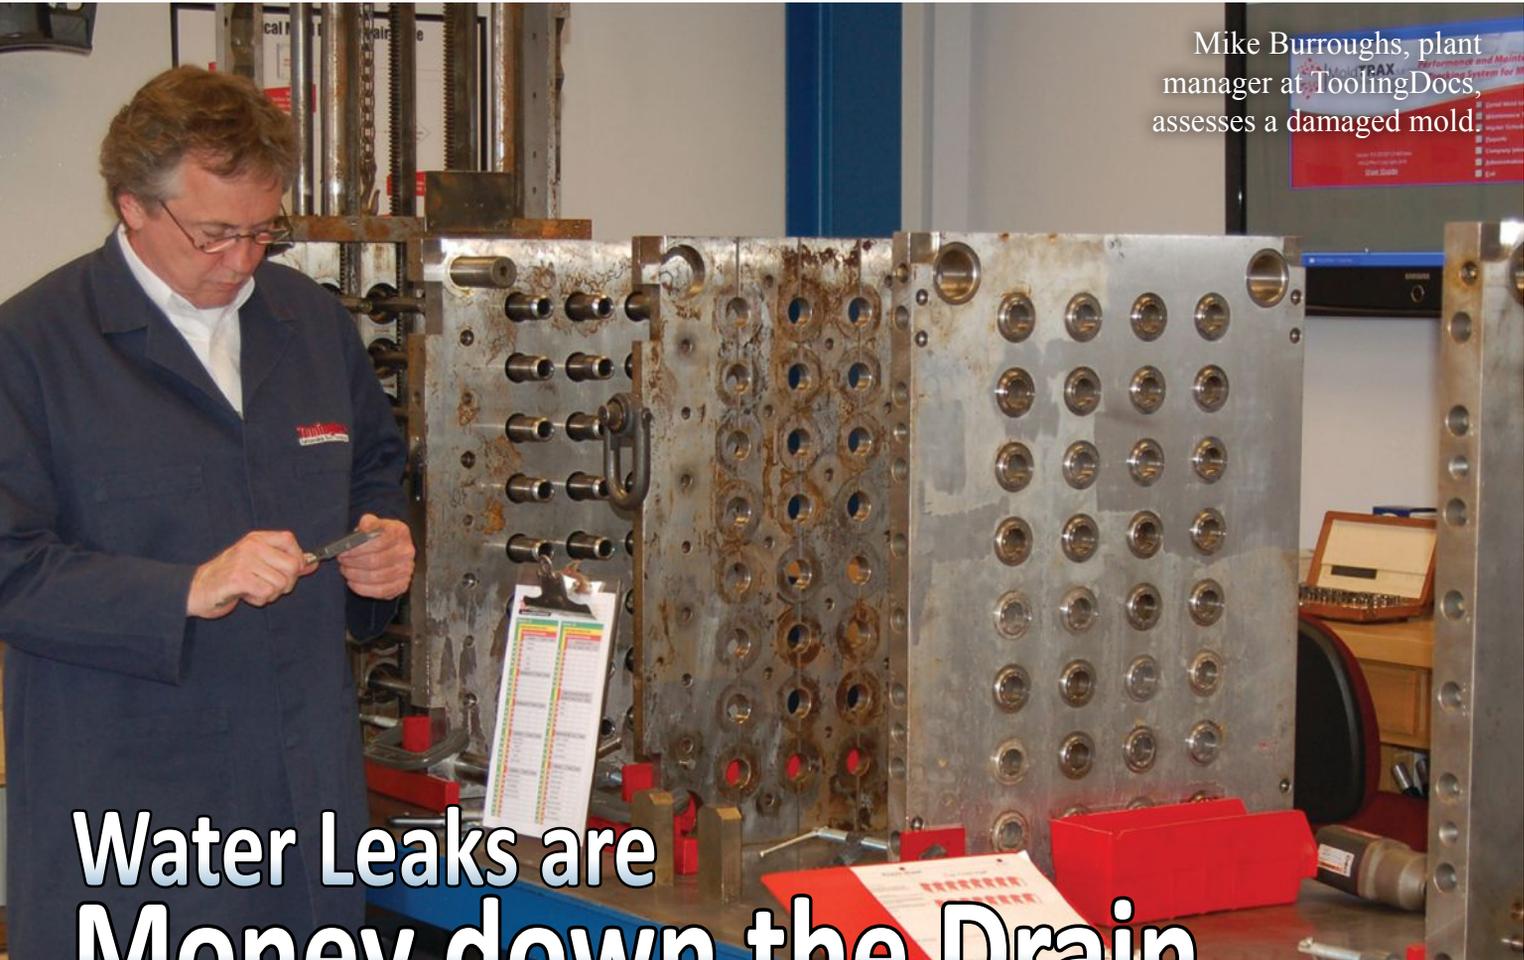
Mike Burroughs, plant manager at ToolingDocs, assesses a damaged mold.

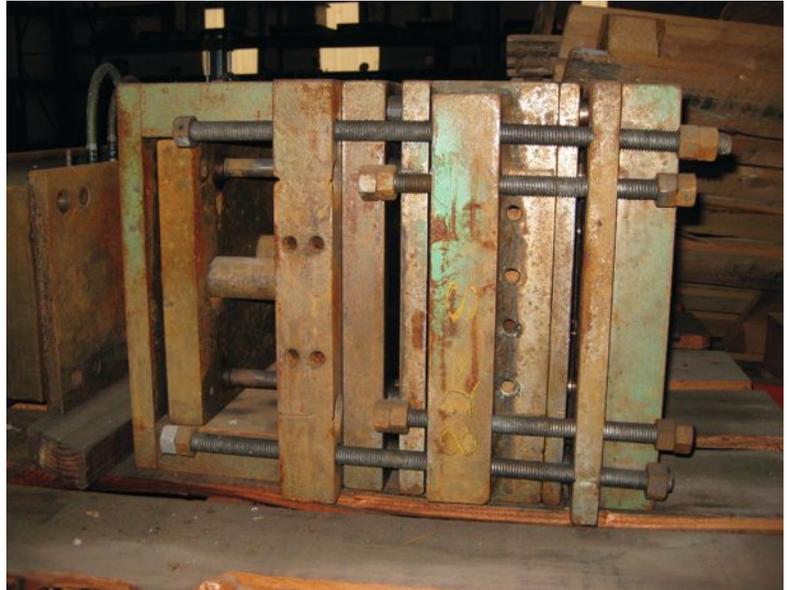
- stuffing a larger o-ring into the pitted gland
- stuffing *two* o-rings into the gland, whereupon the combined cross-sections are slightly larger than the single o-ring
- filling the pits with epoxy (J/B Weld) or
- filling the pitted gland area with silicone sealer (most popular).

These are cheap and short-term fixes that don't solve the problem, causing repair technicians to try again and again for a solution.

Cavity blocks and cores are the typical victims, where the walls and bottoms of glands pit and erode until the o-ring can no longer conform to the depth of the pit and water seeps past. The leaks can be enhanced by a mold’s opening and closing, acting as a virtual pump by slightly moving or shifting tooling with every cycle. This opens stress cracks that would normally not leak during a static bench test of the circuits.
